Applying the Commissioning **Process Embedded in the ASHRAE GPC 37** Guideline.

# Streamline Guidance – Commissioning Flowchart

## **About Lake Hills Church Facilities**

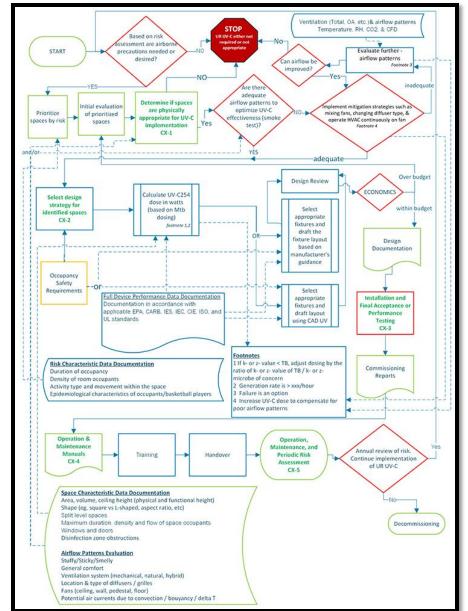
The proposed commissioning design flowchart (see Figure 1, Draft November 2022) maps the entire commissioning process from needs assessment to implementation to build the project brief.

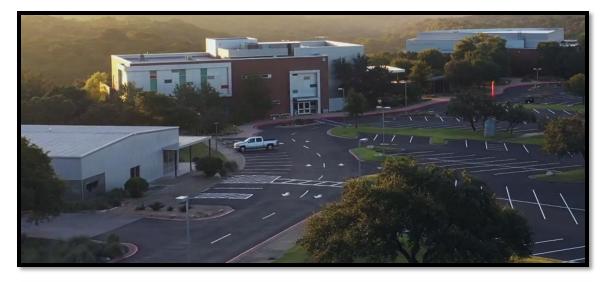
We analyzed the building environments with their pastor and facility manager to evaluate the following factors:

Purpose, Size, Ventilation, Ceiling Construction, Layout, Furniture and Fixtures, Existing electrical appliances. All the buildings have modern HVAC with contingencies for drastically increasing airflow in times of dense occupation.

The HVAC is well maintained and managed giving confidence that a meaningful amount of air mixing is occurring as a matter of standard practice.

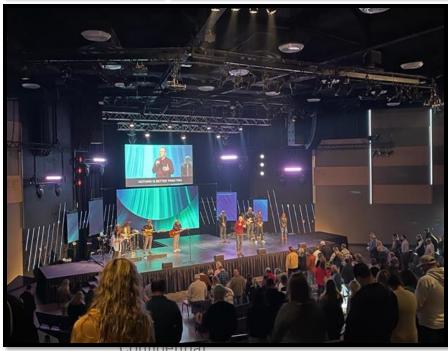
## **Area 1: Worship Center**

Risk Characteristics	
Duration of Occupancy	1 day a week / 3 hours a week
Density of Room Occupants	1,200 seat capacity
Activity type	Sunday Service (Singing / Talking)
Epidemiological characteristics	General Population
Space Characteristics	
Sizes (+ ceiling heights)	115' x 50'x Height from 11' to 30'
Volume	~185,000 Cubic Feet
Shape	Sector
Windows and Doors	No windows, 2 doors
Any Obstructions	Lighthing fixtures, various audio appliances hanging
Airflow Patterns Evaluation	
Ventilation System	Air Conditioning
Location of Diffusers	(see illustration)
Potential Air Current	8-17 ACH

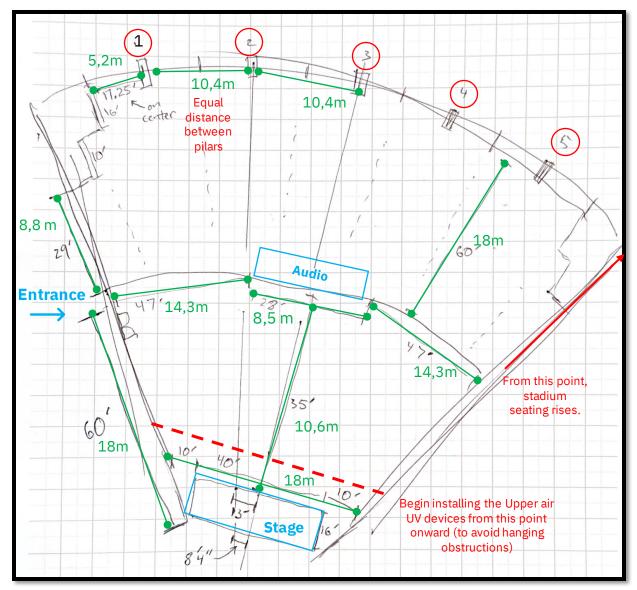
### **Area 1: Worship Center**

1 = Location of the directors of the ceiling steel structure over which the power runs and where the lights are placed.

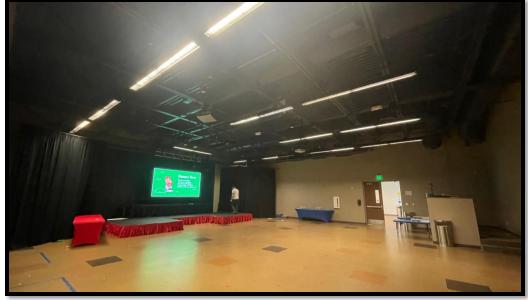
### Area 3: K12 Room

Risk Characteristics	
Duration of Occupancy	1 day a week / 3 hours a week
Density of Room Occupants	Full capacity 100 people
Activity type	Singing / Talking / Play Activities)
Epidemiological characteristics	Children
Space Characteristics	
Sizes (+ ceiling heights)	49' x 45' x 12.6' Height
Volume	~27,800 Cubic Feet
Shape	Square
Windows and Doors	No windows, 2 doors
Any Obstructions	Lighthing fixtures, various audio appliances hanging
Airflow Patterns Evaluation	
Ventilation System	Air Conditioning
Location of Diffusers	(see draw)
Potential Air Current	8-17 ACH

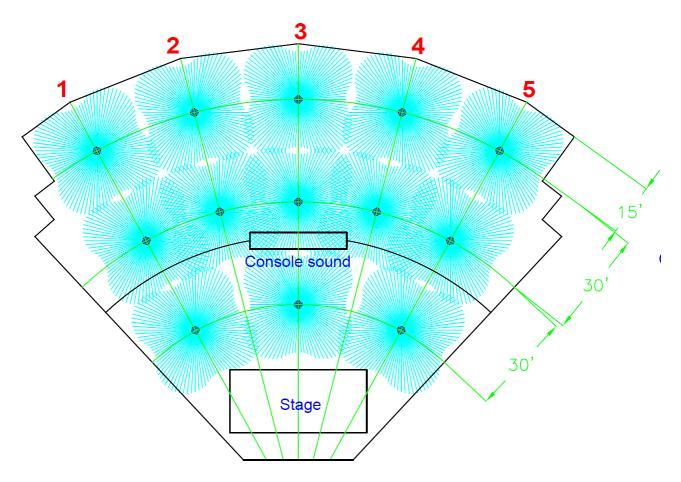
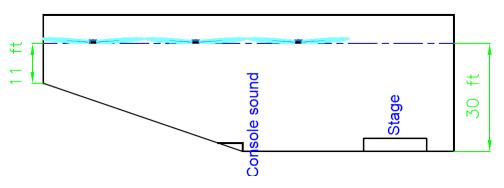
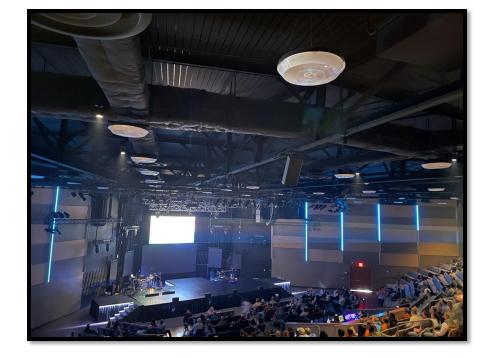
## **Area 1: Worship Center**

13 Devices (UV-FLOW 4/18P-CL)

Too visually disruptive when people are inside the dark.

Ceiling is not easily accessible for maintenance.

Alternative viable solution to add GUV to the HVAC system serving the Worship Center

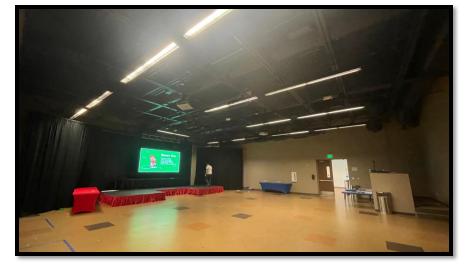
#### Area 3: K12 room

Option 1: 2 Devices (UV-FLOW 4/18P-CL)

Option 2: 4 Devices (UV-FLOW 16-WL)

## Option 1 14'(4,26) 21'(6,40) 14'(4,26) 22.5 (6,85)45'(13,7m) 22.5 (6,85)12.6 (3,8m)(3,5m)49'(14,9m) 49'(14,9m)

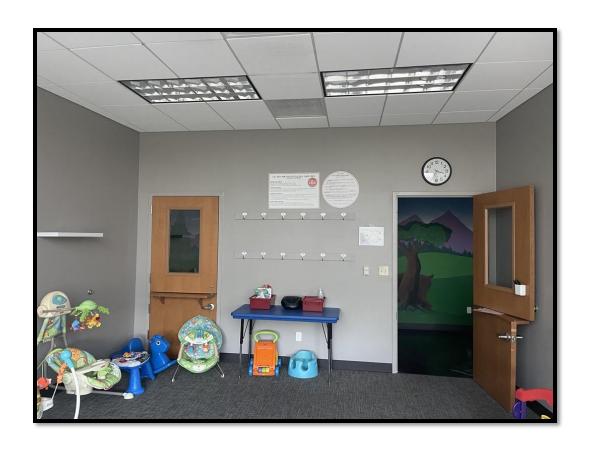
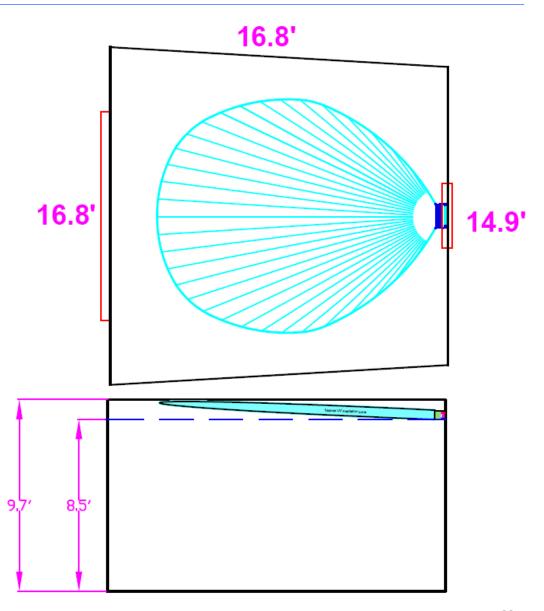
## **Area 2: Nursery (3 identical rooms)**

1 Device (UV-FLOW 8-WL)

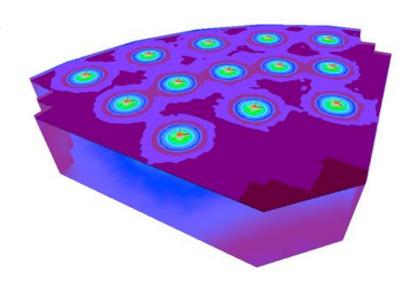
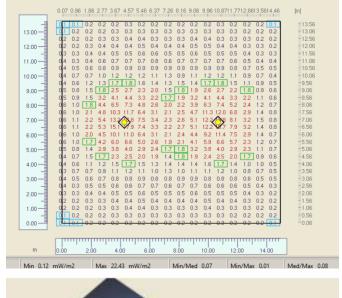
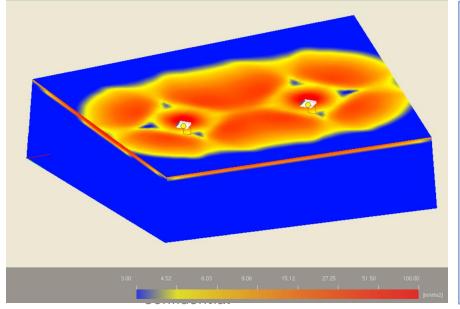
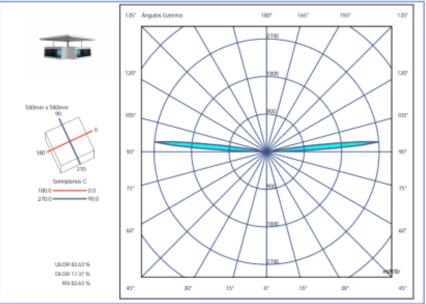
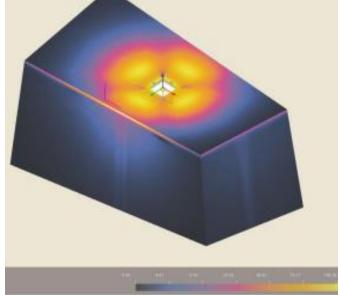
PO 2.1 m - Irradianza Orizzontale

Beyond producing CAD Drawings, we modelled/calculated dosage and product performance using goniospectrophotometry (i.e., IES files) to select the products and placement.

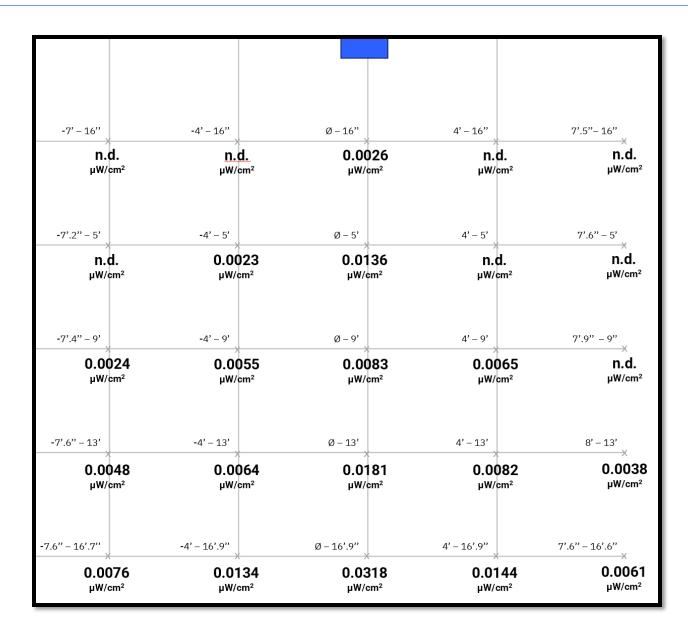
Grid of measured values at 7 feet from the ground.

Accepted Threshold Limit Value established by ACGIH is 6,000 microjoules per 8 hours for eye exposure and 10,000 microjoules per 8 hours for skin exposure.

Eye Exposure Limit Maths = .2 microwatt/cm<sup>2</sup>
